## Case 271 : Narrative

Case Vehicle (A): 1997 Ford	Vehicle (B): 1997 Volkswagen
Type: Taurus GL, 4-door sedan	Type: Golf GL, 4-door sedan
Driver: 52-year-old male	Driver: 37-year-old female
CDC: 12-FDEW-1	CDC: 99-0000-0

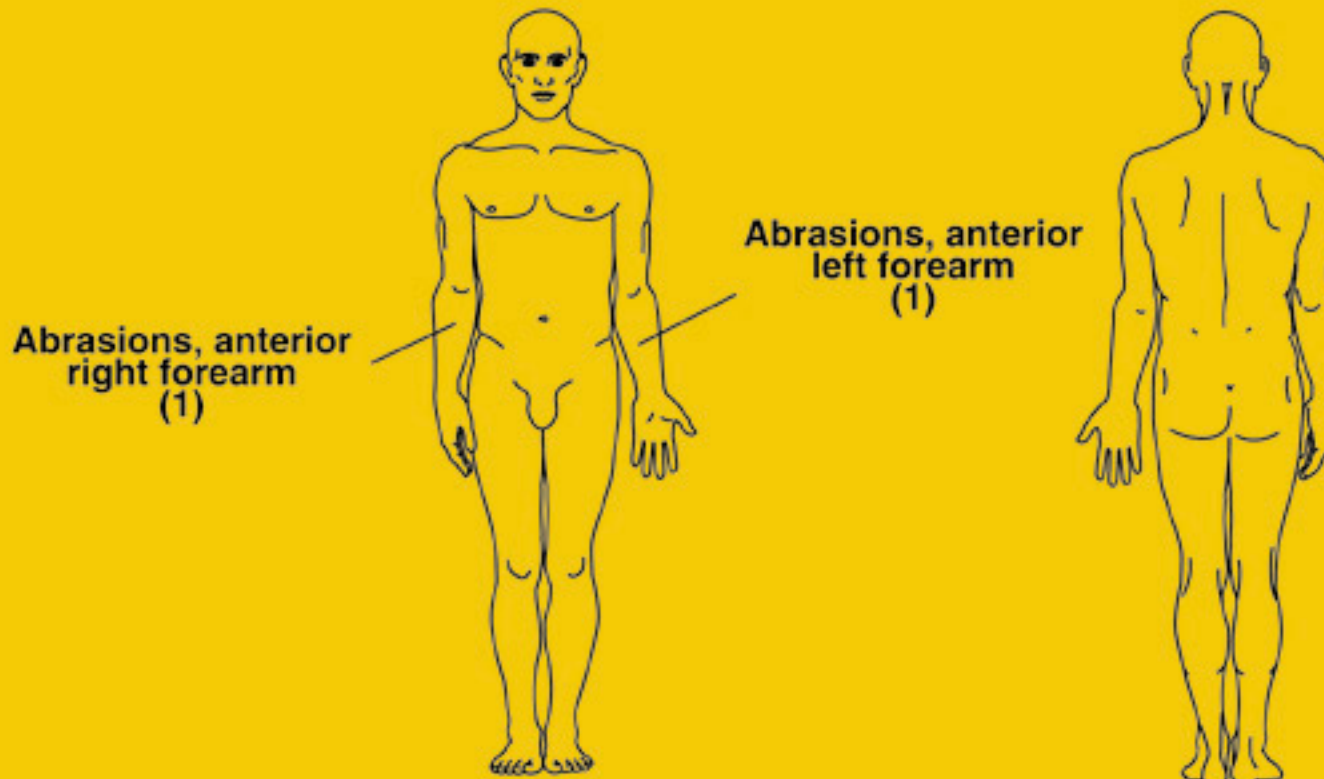
During the frontal impact, the driver moved forward relative to the vehicle interior. He sustained abrasions to the anterior areas of his left and right forearms, due to contact by the airbag.

Occupant: Driver	Age: 52 years	Gender: Male		
Restraints: 3-point belt worn; airbag deployed	Stature: 180 cm (5 ft, 11 in)	Mass: 72 kg (160 lb)		
Injury Description	A.I.S.	Injury Source		
		Definite	Probable	Possible
—	—			
Abrasions, left anterior forearm	1	Airbag	—	—
Abrasions, right anterior forearm	1	Airbag	—	—
Maximum A.I.S. Level	1	—	—	—
Injury Severity Score	1	—	—	—

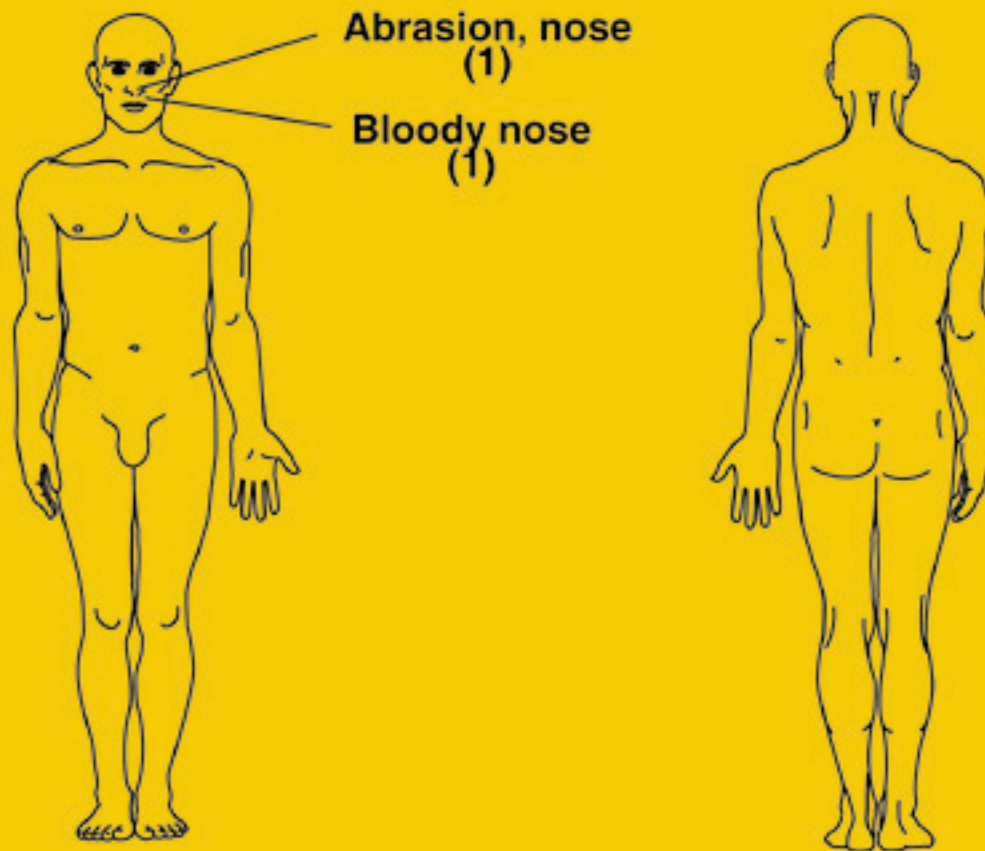
During the frontal impact, the right-front passenger moved forward relative to the vehicle interior into the belt restraint and passenger airbag. He sustained an abrasion to his nose and a bloody nose, due to contact by the airbag.

Occupant: Right front	Age: 12 years	Gender: Male		
Restraints: 3-point belt worn; airbag deployed	Stature: 157 cm (5 ft, 2 in)	Mass: 59 kg (130 lb)		
Injury Description	A.I.S.	Injury Source		
		Definite	Probable	Possible
—	—			
Abrasion, nose	1	Airbag	—	—
Bloody nose	1	Airbag	—	—
Maximum A.I.S. Level	1	—	—	—
Injury Severity Score	2	—	—	—

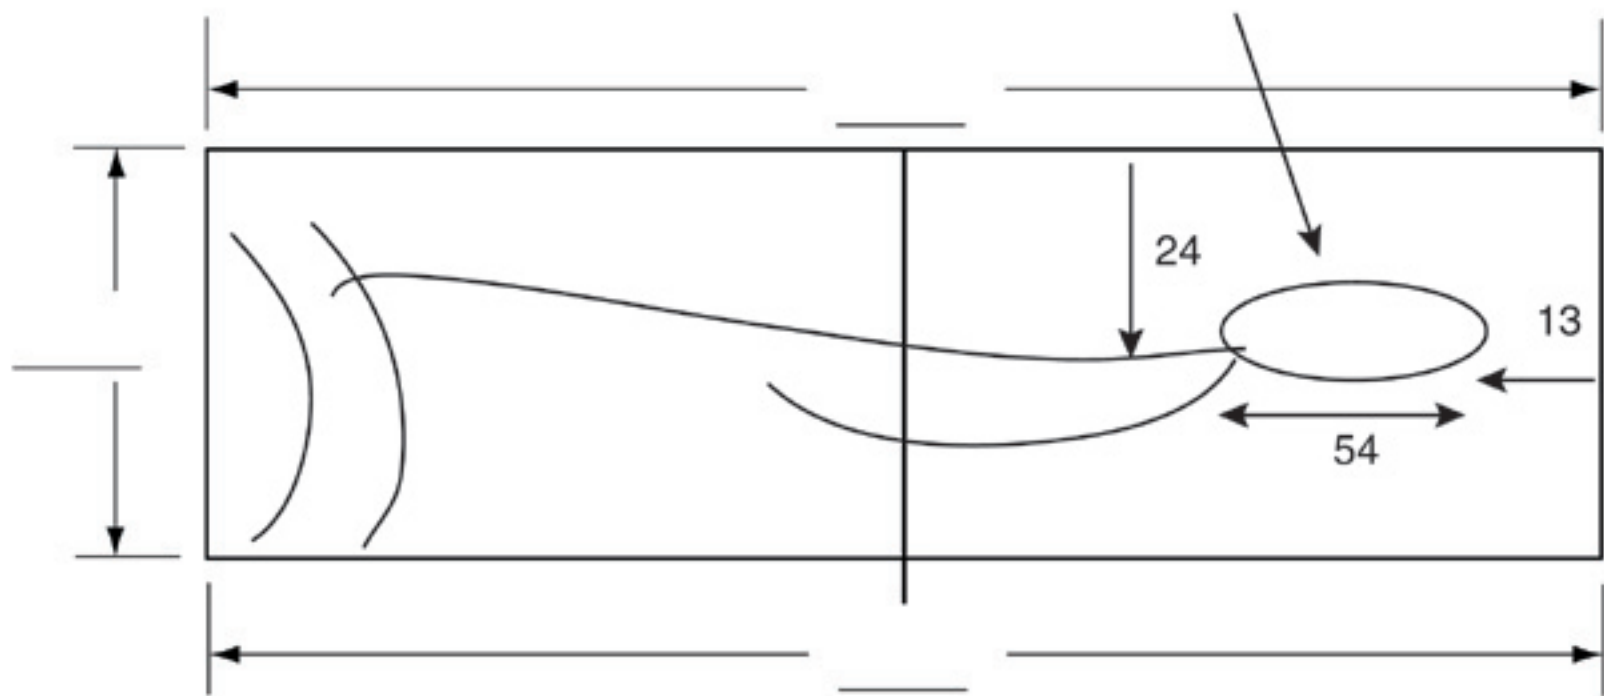
# WINDSHIELD MARK ON CASE VEHICLE:

right airbag cover was separated from tether strap  
and contacted and cracked the windshield
